Tensile strength test

By commission of Swedwire AB tensile strength test on galvanized road barrier ropes were performed.

Designation: Galvanized road barrier ropes, 3 x 7 with wire diameter of 3 mm.
Test objects with a length of 1.5 m and nominal diameter 19 mm,
see Figures 1-2

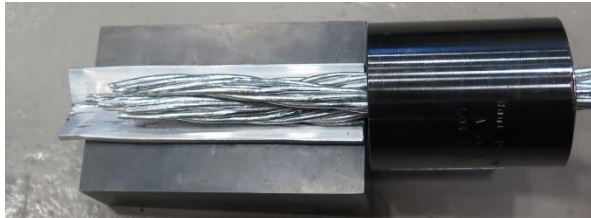
Figure 5. Test object No. 2, location of fracture.

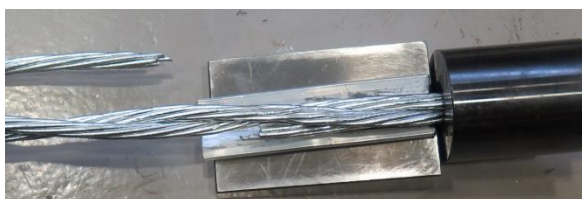
Figure 6. Test object No. 3, location of fracture.
